Burpham Church Fabric Report 2022

Quinquennial Inspection Reports from May 2022 - Summary

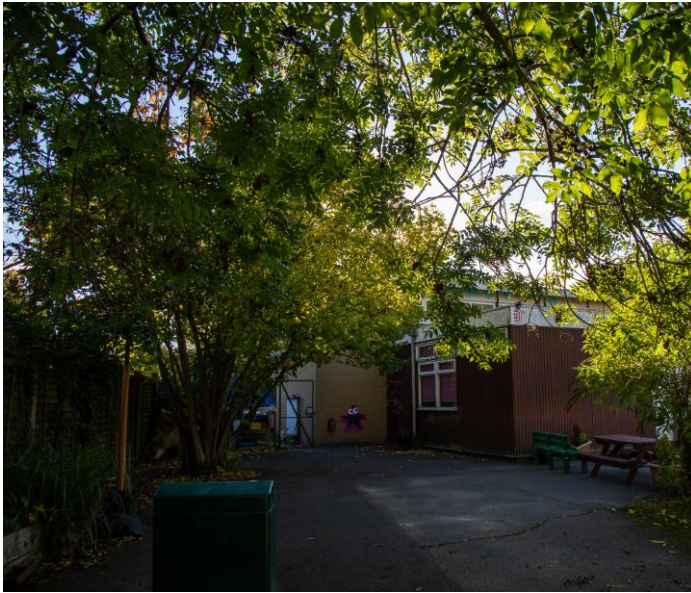
One of the other issues the PCC considered was the hazelnut tree near the front of the site which was problematic, particularly for Preschool, both because of its detrimental effect on the play area, but particularly as one of their pupils had a nut allergy. It took some time to get approval to remove the tree, which required a full Faculty for approval, which took quite some time to secure. After the necessary consent the tree was removed by a working party in September. Because of its concern at removing a tree the PCC wished to compensate in the way which would ensure the greatest beneficial effect. It was therefore decided to support the Woodland Trust who had indicated that a £100 donation would enable them to create and care for enough woodland to capture and store around four tonnes of carbon. Our donation of £200 should therefore create eight tonnes of carbon capture, greatly in excess of the effect of the removal of one tree.

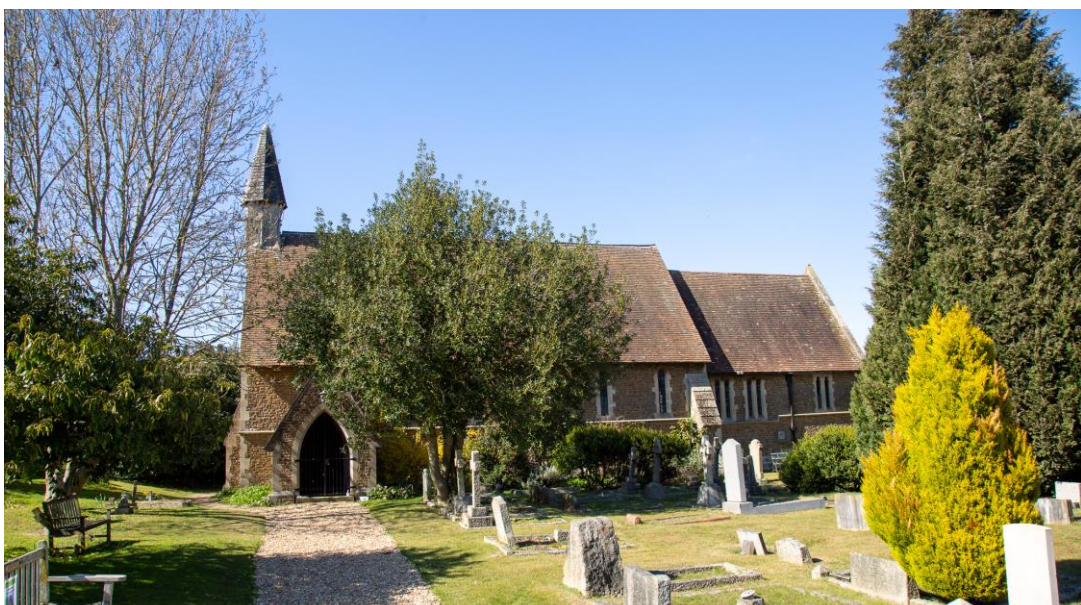
The issues raised in the QI were very similar to those raised five years ago, but mostly those to be addressed "within two years", had only moved to "within 12-24 months". It does remain that the church needs completely re-roofing (and a lot of work on the rainwater goods), but the report mentions that "re-roofing has been recommended in some form since 1990" which although making it overdue shows it has not deteriorated very rapidly.

However there was increased concern about the roof to the north slope of the Chancel, including the Vestry, but after discussion with the Inspecting Architect it was felt not to be needing immediate attention.

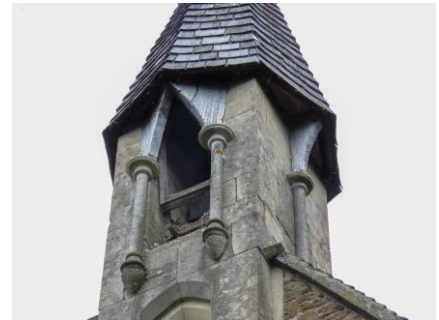
There was also concern at the bellcote, including “about the degree of movement on the north-west corner of the turret” with a suggestion it is “inspected in the near future to ascertain whether emergency works are needed”. There were a few minor but priority items mainly to prevent pigeons etc entering roof and other spaces, including the bellcote. It was felt that the bellcote could be inspected while dealing with other works to prevent pigeon ingress etc.

A project, also under the leadership of the Inspecting Architect, to deal with the priority items, and arrange scaffold access to the bellcote to check if further work is required, is also in hand.
