Burpham Church Fabric Report 2022

Quinquennial Inspection Reports from May 2022 - Summary

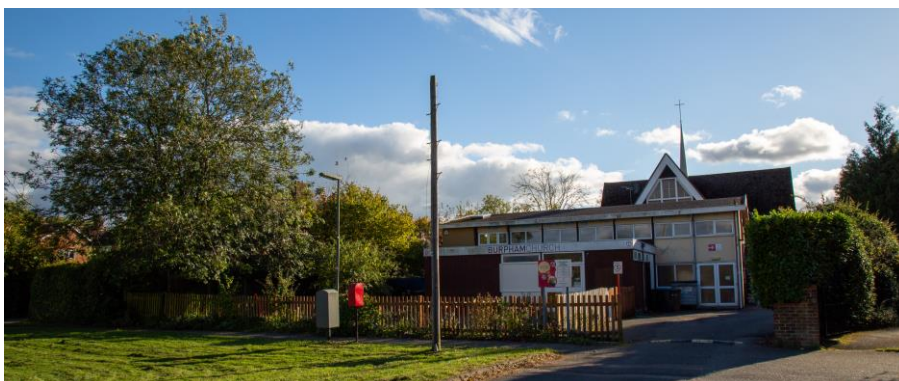
The PCC determined that as well as the higher priority items for the church, hall, and areas in between, necessary to preserve those buildings likely to be needed to be retained in the long term, work should also be done to minimise the risks to Preschool. Although the flat roofed area to the front of the site was likely to need to be replaced, it was still important to Preschool and so work would be done to prolong its life, whilst minimising expenditure. Part of this could be done by a working party but the rest would be carried out in a package by a contractor procured and managed by the Inspecting Architect. The working party carried out their work in September 2022, but with pressures generally on the building industry it took some time to get suitable prices for the other work, now scheduled for the February 2023 half term, to reduce the risk of affecting Preschool.
